TECHNICAL NOTE 3935

HYDROGEN-OXYGEN EXPLOSIONS IN EXHAUST DUCTING

By Paul M. Ordin

Lewis Flight Propulsion Laboratory Cleveland, Ohio

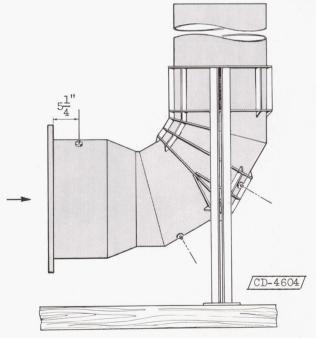
To study the role of the supporting ribs welded around the elbow with the thrust support in position several ribs were removed, as indicated by figure 13, and run 28 was made. The pressures obtained were 272 lb/sq in. gage at station 4, 246 lb/sq in. gage at station 6, and a face-on pressure of 882 lb/sq in. gage at station 8. The elbow was not distorted, but several cracks were noticed in the structure where some of the ribs had been removed. Studies of the elbow indicated that the cracks were probably due to the damaging of the welds where the ribs had been removed.

(f) Same as (e), with several
 ribs removed.

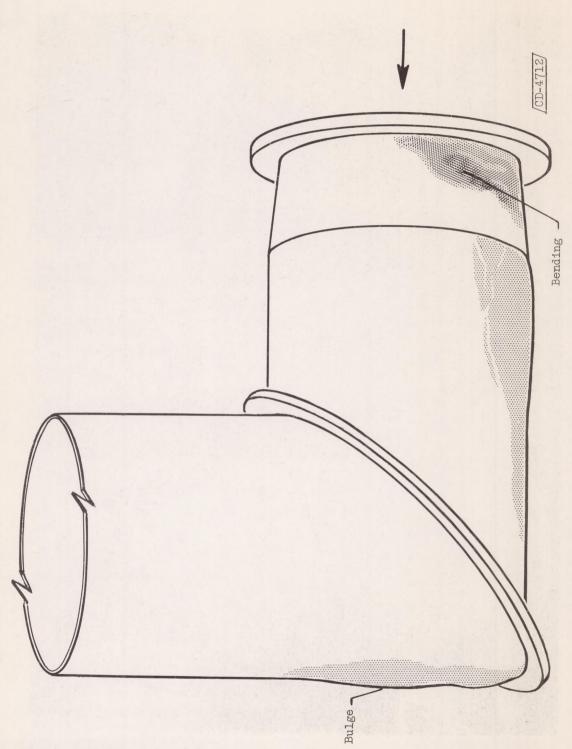
The initial elbows fabricated (figs. 7(b) to (d)) and tested under detonation conditions suffered some sort of failure. In general, the principal damage was caused by the buckling or cracking of the 90° elbow at the flanged connection to the main duct. The single-miter elbow (fig. 7(b)) in addition to bending near the flanged connection was bowed out at the elbow section axially with the duct (fig. 10). The total pressure was 910 lb/sq in. gage, which is equivalent to a pressure-rise ratio of about 63 compared to a static-pressure-rise ratio of about 21 compared

Figure 10. - Failure of single 900 miter elbow.

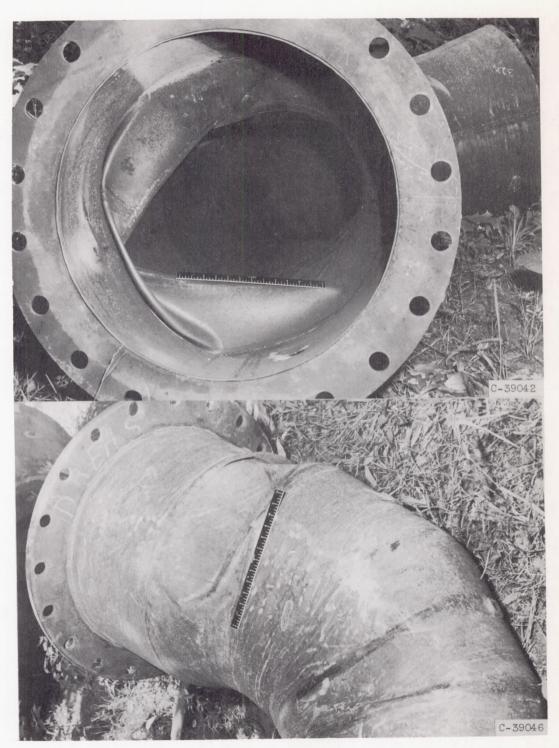
duct and thus prevent the discontinuity stresses at the juction from exceeding the membrane stress in either part. A single run with this elbow resulted in severe buckling near the flanged connection (fig. ll). The stress concentration was considerably higher on this duct than on any of the others investigated because the material used was 16-gage instead of 14-gage. The pressure on the section of the elbow axial with the duct was 1250 lb/sq in. gage, while on the bottom of the elbow section a value of 505 lb/sq in. gage was obtained. The pressure 1250 lb/sq in. gage was the highest detonation pressure recorded in the program and may not be a correct value because of the destruction of the elbow. The fourth elbow investigated was a multimiter elbow similar to the previous one but constructed of 12-gage material and reinforced by metal ribs welded to the structure (fig. 7(d)). The detonation (run 24) resulted in cracks in the horizontal section near the flanged connection to the horizontal duct and was believed to be caused by the excessive bending moment.

Figure 11. - Damage to multisectioned elbow constructed of 16-gage steel (fig. 7(c)).

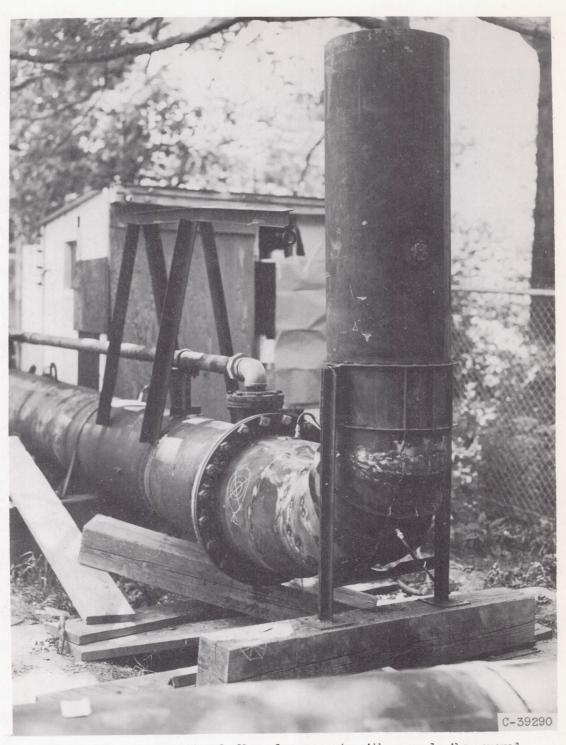
A subsequent run (run 28) was made with some of the supporting ribs removed (fig. 13), but the results were not conclusive, since a considerable number of cracks developed by the detonation were along the areas where the ribs had been removed. It was believed that when the ribs were cut away the structure was weakened.

Figure 13. - Multisectioned elbow plus supports with several ribs removed.
